RE: First Quarter 2000 Inspections

RE: First Quarter 2000 Inspection Report

IMPOUNDMENT INSPECTION AND CERTIFIED REPORT		Clear Water Pond	
Permit Number	ACT/007/035	Report Date 04/13/00	
Mine Name	SUNNYSIDE REFUSE AND SLURRY		
Company Name	SUNNYSIDE COGENERATION ASSOCIATES		
Impoundment Identification	Impoundment Name	Clear Water Pond	
	Impoundment Number	004	
	UPDES Permit Number	UT 024759	
	MSHA ID Number	N/A	
IMPOUNDMENT INSPECTION			
Inspection Date	03/21/00		
Inspected By	Scott Carlson		
Reason for Inspection (Annual, Quarterly or Other Periodic Inspection, Critical Installation, or Completion of Construction)		First Quarter Inspection 2000	
<p>1. Describe any appearance of any instability, structural weakness, or any other hazardous condition.</p> <p>NONE</p>			
Required for an impoundment which functions as a SEDIMENTATION POND.	<p>2. Sediment storage capacity, including elevation of 60% and 100% sediment storage volumes, and, estimated average elevation of existing sediment.</p> <p>Storage Capacity = 4.9 acre-feet Maximum Sediment Depth Elevation = 6527 Existing Sediment Elevation = 6523+-</p>

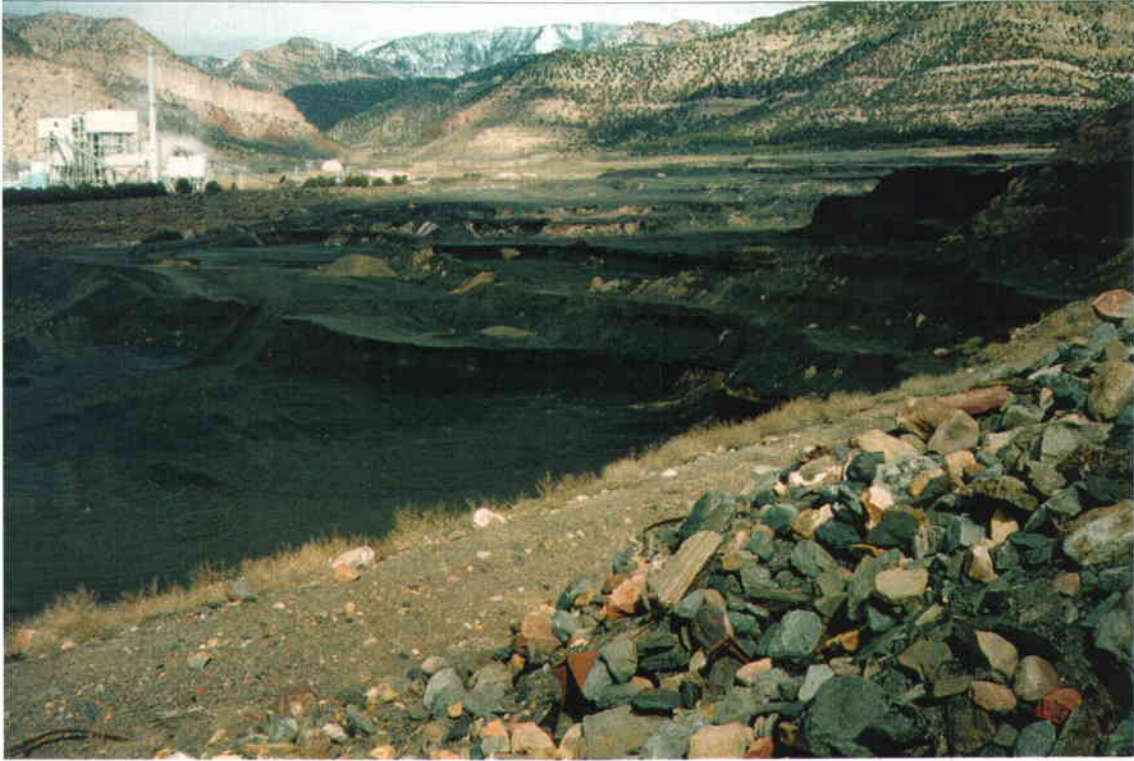
West Cell/Refuse Pile

During the fourth quarter 1999, excavation of refuse material had damaged a small portion of the westerly access road around the refuse pile. This quarter's inspection showed that the operator had repaired the road and adjacent ditch and berm.

No smokers visible

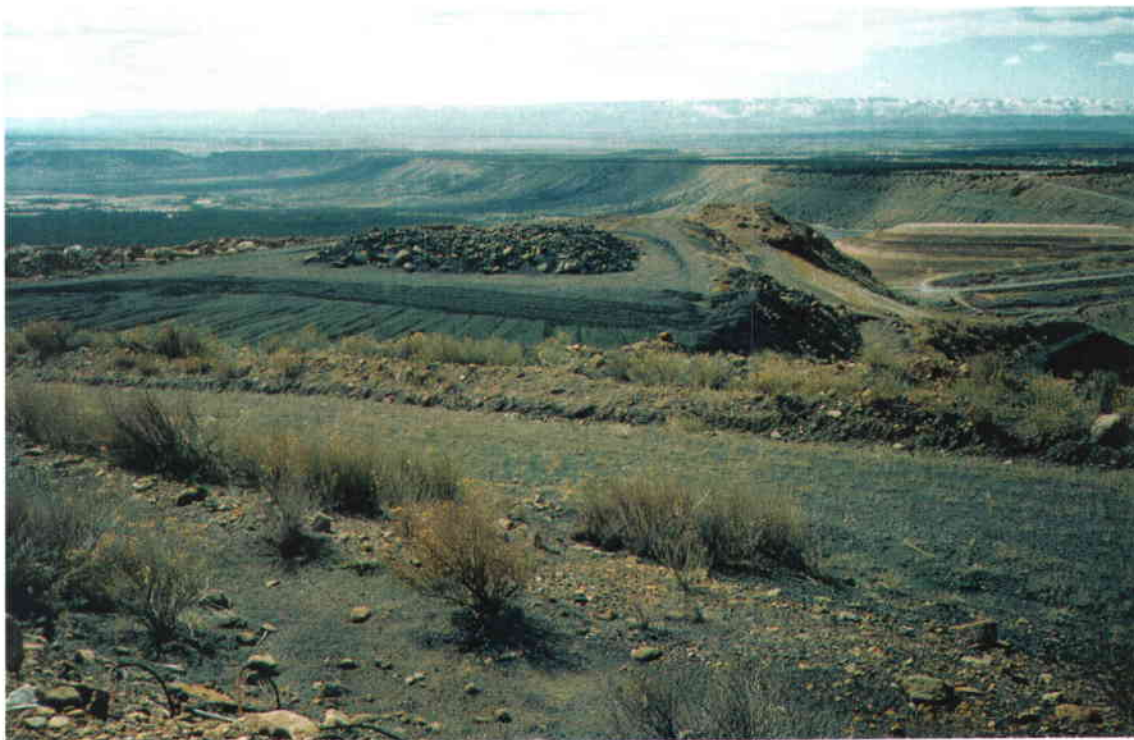
Excess Spoil Disposal Area # 1

Analytical results from samples taken of the material placed in this disposal area are submitted with this quarter's report.

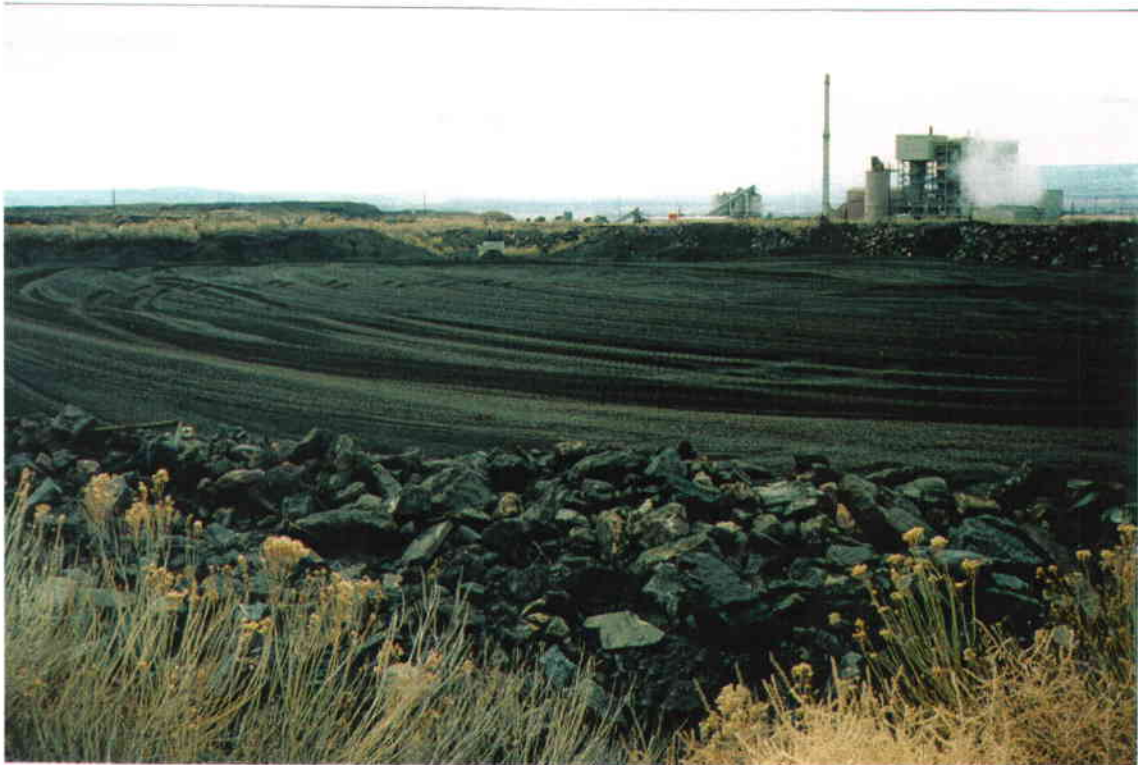
Excess Spoil Disposal Area # 2

Analytical results from samples taken of the material placed in this disposal area are submitted with this quarter's report.
